Evaluation of a Buffer Zone at an Ilmenite Mine operated by Rio Tinto on the Shores of Lakes Besaroy and Ambavarano, Madagascar

**Steven H. Emerman,
Malach Consulting**

Report to Andrew Lees Trust, submitted May 27, 2018

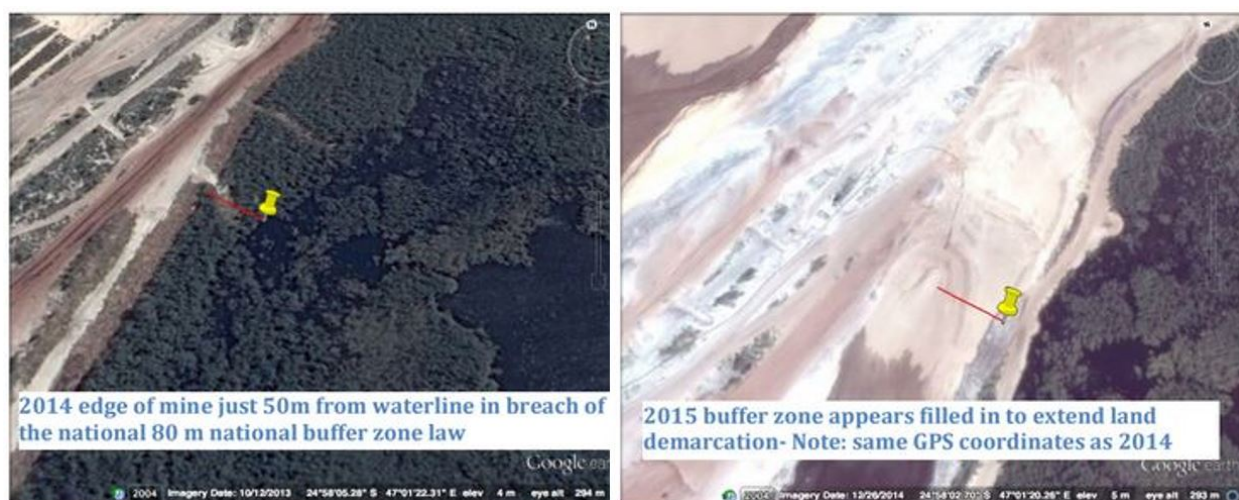
Figure 2A. Andrew Lees Trust (Orengo, 2017) has used Google Earth images to claim that Rio Tinto has constructed mining infrastructure within the 80-m undisturbed buffer zone (left-hand photo) and has filled in the lake in order to move the buffer zone in the direction of the lake (right-hand photo). The location of these images is equivalent to Site 2 of Ozius Spatial (2018) (see Figs. 4, 5A, 7A-B).

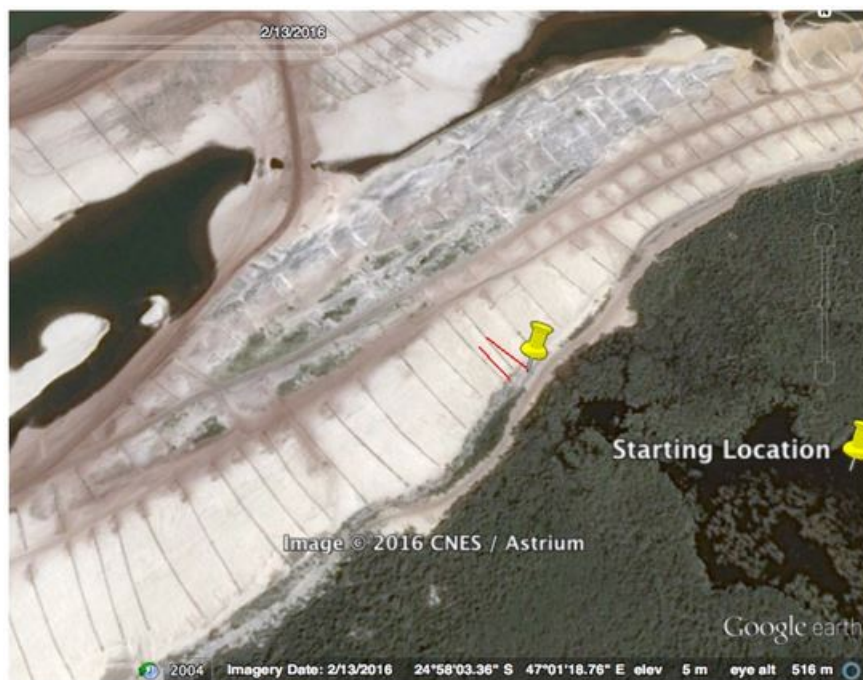
Figure 2B. Andrew Lees Trust (Orengo, 2017) has used Google Earth images to claim that road access has been constructed on what was originally the lake bed. The location of these images is equivalent to Site 2 of Ozius Spatial (2018) (see Figs. 4, 5A, 7A-B).

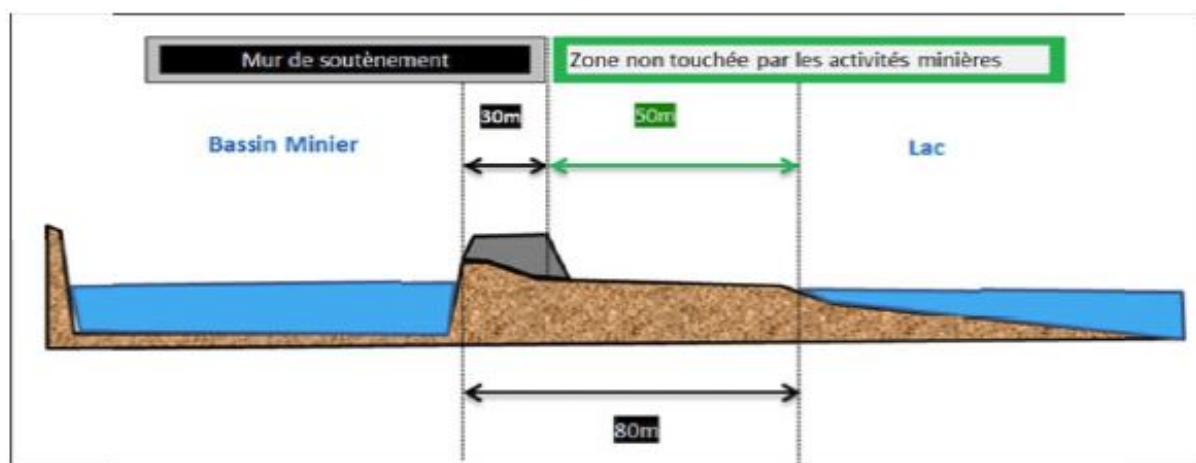
Figure 3. In order to prevent water movement from the mining basin into the lake or river, an 80-m undisturbed buffer zone is preserved between the mining basin and the water bodies. In addition, the water level in the mining basin is maintained 1-2 meters below the surface of the natural water bodies. Under an agreement between Rio Tinto and the National Office of the Environment (ONE), a 30-m wide, 4-m high earthen dam has been built on top of the undisturbed buffer zone. Diagram from QIT Madagascar Minerals (2015).

The “lake protection berm” is 4 meters high and 30 meters wide (QIT Madagascar Minerals, 2015, see Fig. 3) and was designed with a factor of safety of 1.3 for a 50-year flood (Rio Tinto, 2017). In addition, the water level in the mining basin is maintained 1-2 meters below the surface of the natural water bodies and 3 meters below the elevation of the adjacent

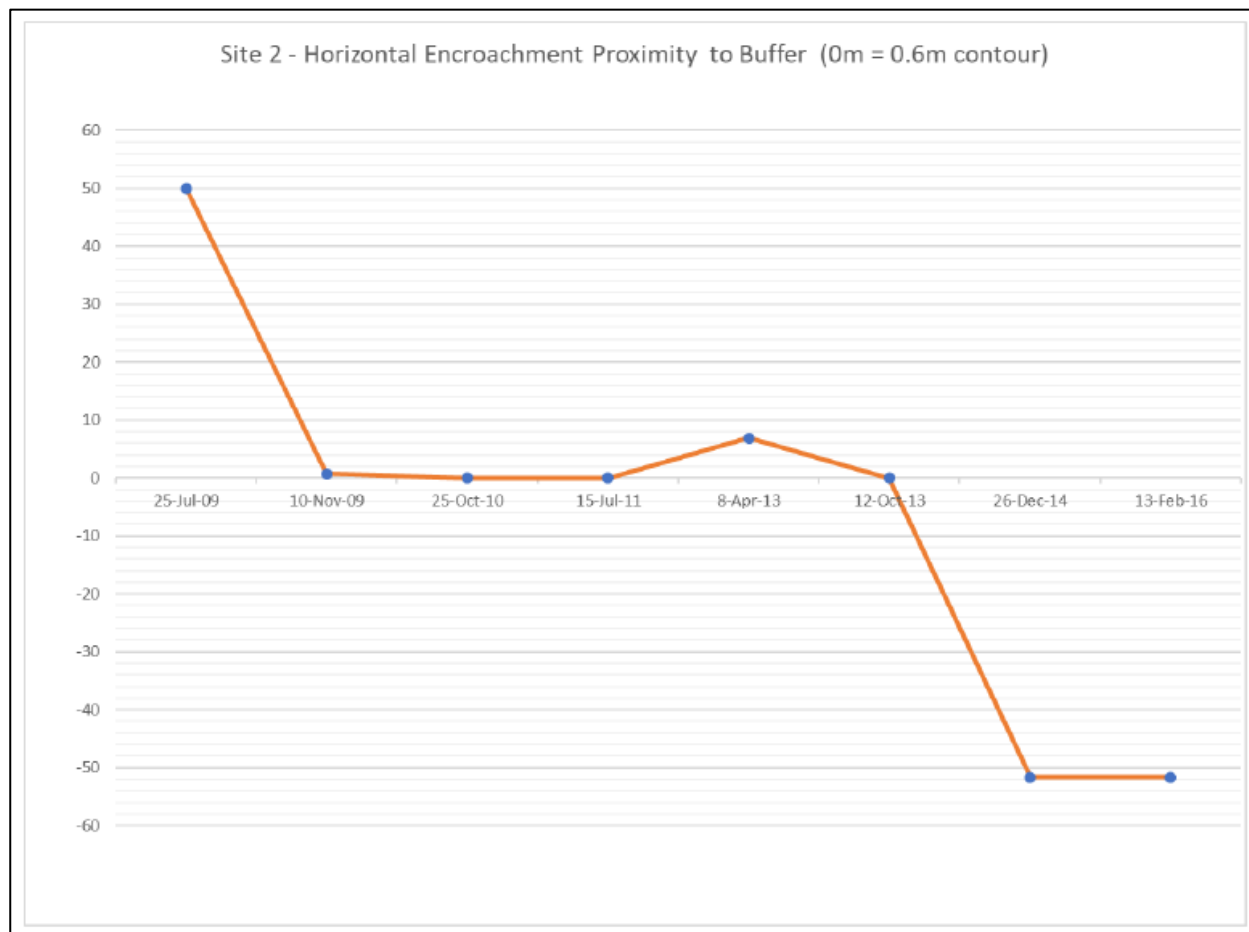
Figure 9. In 2014, Rio Tinto reached an agreement with the National Office of the Environment (ONE), according to which Rio Tinto was permitted to carry out dredging at Site 2 (as denoted by Ozius Spatial (2017, 2018)) within 50 meters from a natural water body, but no closer. However, by the beginning of 2014, the mining operation had already encroached to the edge of the lake bed (defined as the 0.6-m contour by Rio Tinto (2017)). By the end of 2014, the mining operation had advanced 52 meters onto the lake bed.

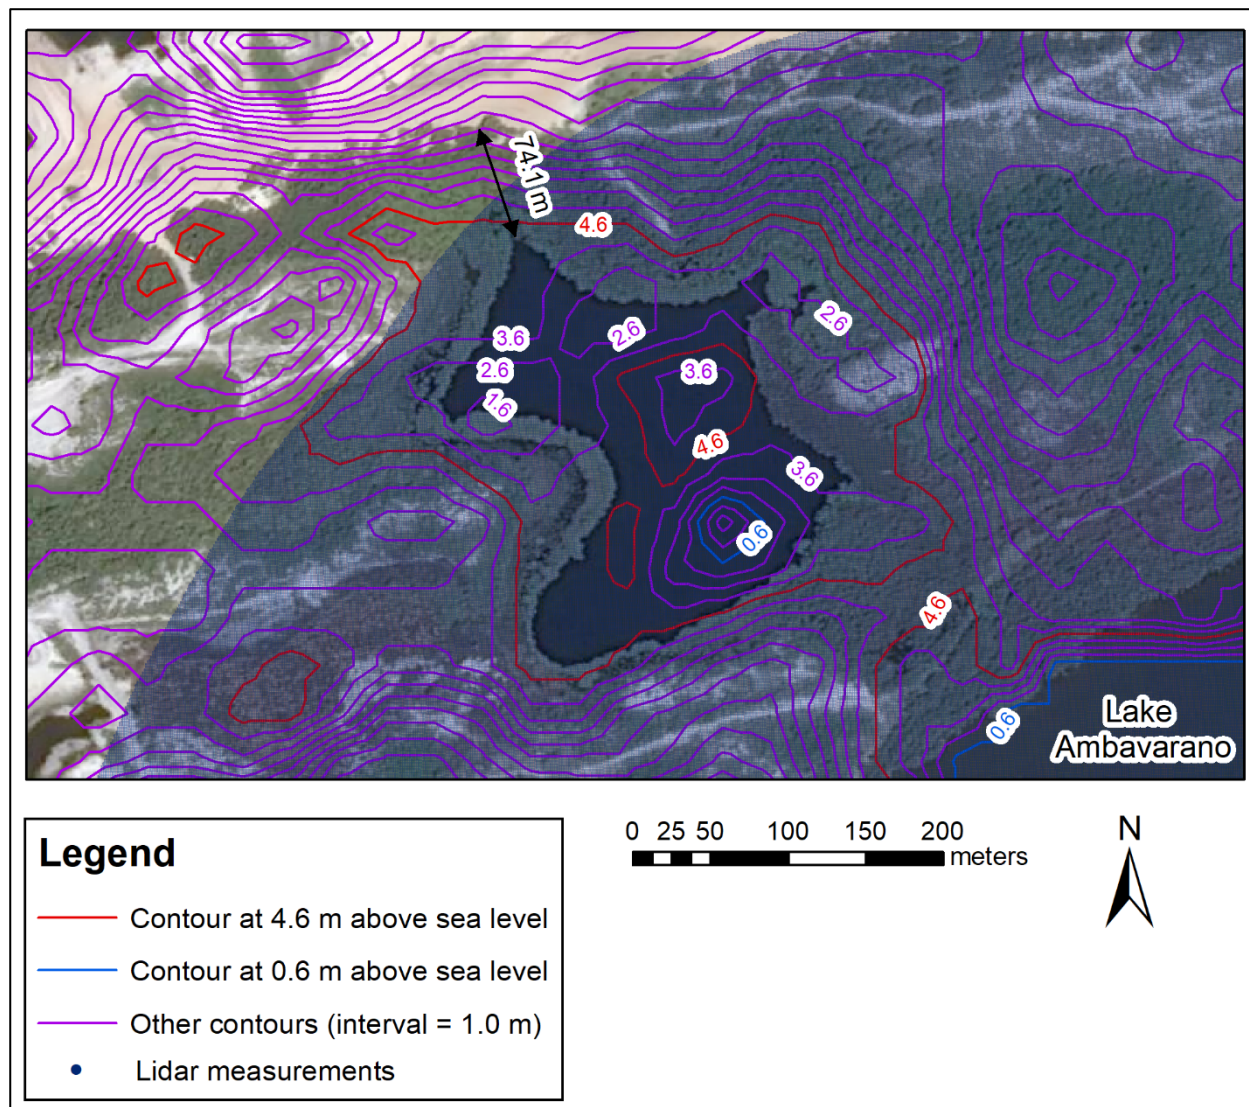
Figure 10C. The Lidar survey carried out by Rio Tinto in 2012 does not show sufficient coverage in the vicinity of Rectangle C (see Fig. 10A). On that basis, the satellite elevation data should be used to investigate encroachment in this region. This figure is identical to Fig. 7C with the addition of the locations of the Lidar measurements. The contours are based upon the 30-m elevation data from the Shuttle Radar Topography Mission (NASA, 2018). Contouring was carried out using ArcMap 10.6 Spatial Analyst with maximum accuracy and minimum smoothing.

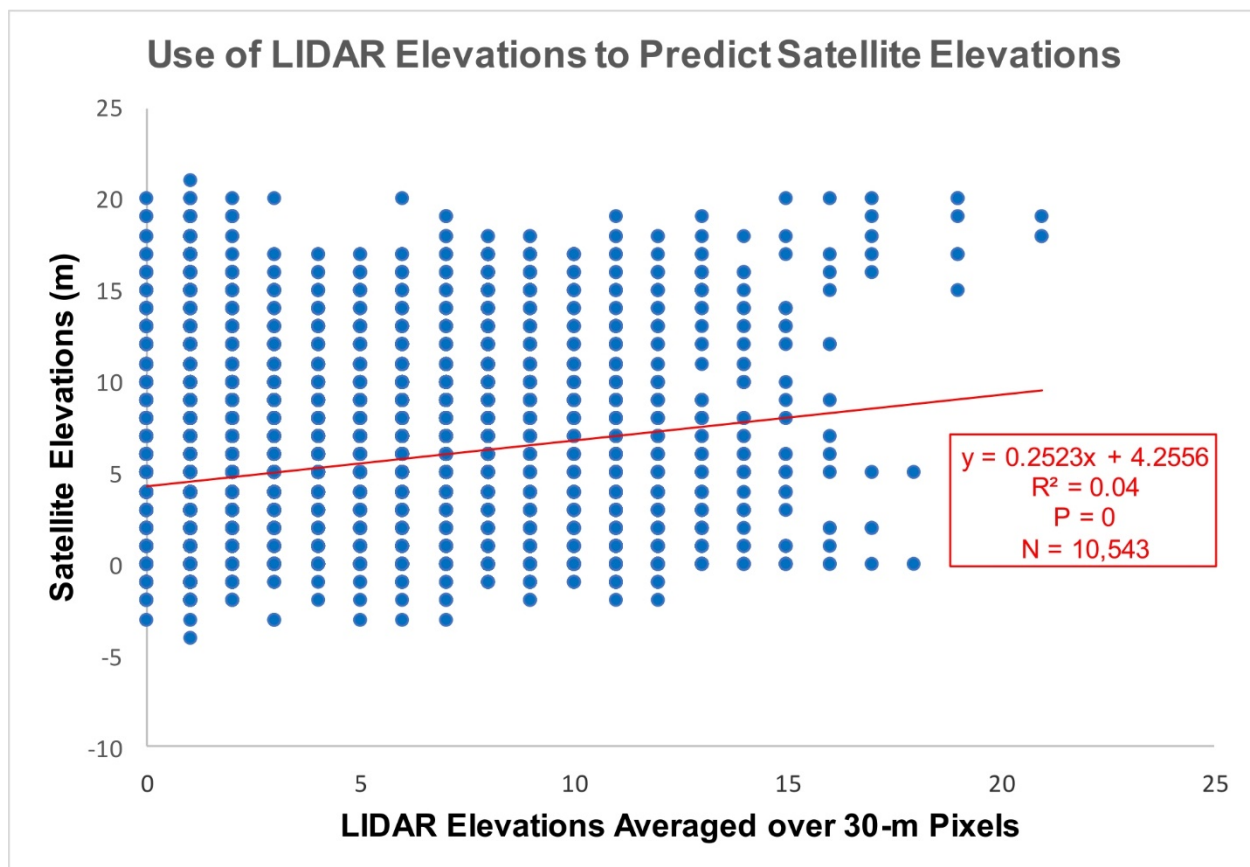
Figure 11. The ability of the Lidar measurements carried out by Rio Tinto to predict the elevations from the Shuttle Radar Topography Mission (NASA, 2018) was tested by averaging the Lidar measurements over the same 30-m pixels as were used by the satellite data. The averages were also rounded to the nearest meter for consistency with the satellite data. The variation in the Lidar data predicts only 4% of the variation in the satellite data, although the prediction is statistically significant ($P = 0$). The intercept of the best-fit regression line implies a vertical offset of 4.3 meters between the two data sets.

The best-fit regression line that predicted the satellite elevations from the Lidar elevations had an intercept of 4.26 meters with a 95% confidence interval of 4.14-4.37 meters (see Fig. 11). This vertical offset is consistent with the determination by Rio Tinto (2017) that the estuaries have an elevation of 0.6 meters above sea level and the determination by this study that the estuaries have an elevation of 4.6 meters above sea level, equivalent to a 4-m vertical offset. (Recall that the resolution of the satellite data is only 1 meter.) The source of the vertical offset cannot be determined without knowing how the Lidar data were calibrated. It is possible that the Lidar data were never calibrated because, as mentioned above, only relative elevations are needed to document compliance with a buffer zone.

The source of the considerable scatter in the plot of satellite elevation vs. Lidar elevation is more difficult to explain (see Fig. 11). The correlation is certainly statistically significant ($P = 0$), although the variation in the Lidar data explains only 4% of the variation in the satellite data. It is not possible to explore this question any further without knowing the methodology behind the Lidar data. The most important pieces of missing information are the locations of the control points, how the control points were used to process the data, and how the position of the aircraft was determined.
